SUBJECT: Temporary Slope Repair for the Hillside Stabilization at
Seeley Creek WWTP

GEOTECHNICAL SLOPE DISTRESS INVESTIGATION & TEMPORARY REPAIR REPORT

SEELEY CREEK WASTEWATER TREATMENT PLANT CLARIFIER AREA City of Crestline, San Bernardino County, California

CONVERSE PROJECT No. 24-81-141-01

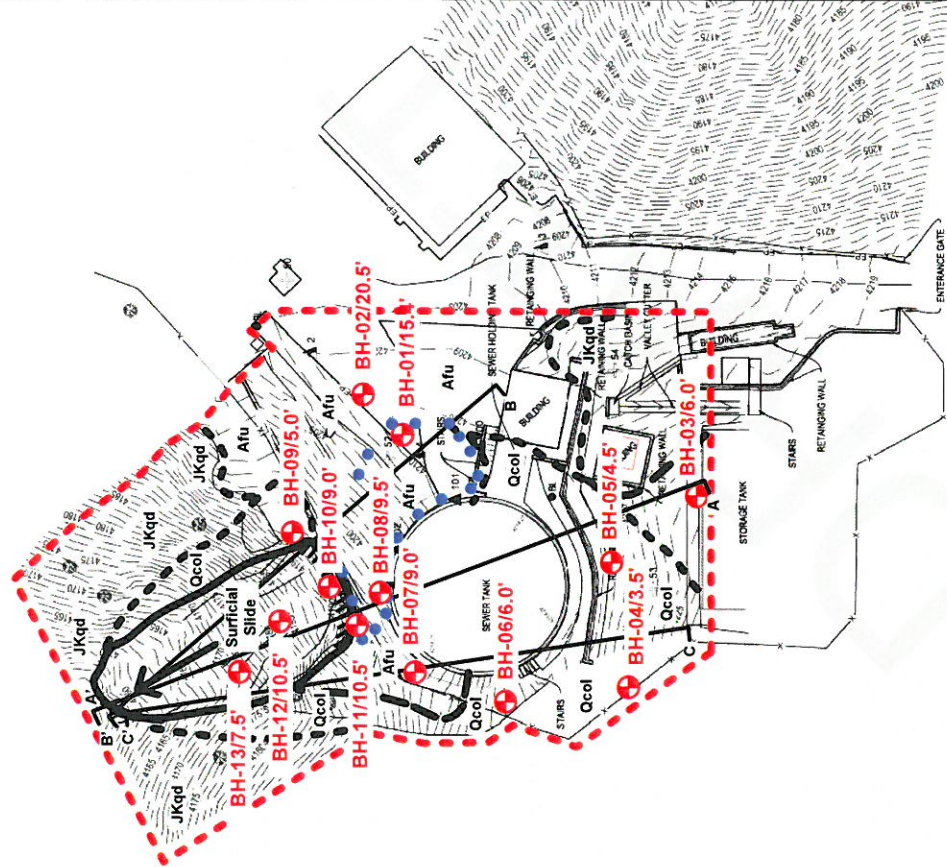
Approximate Boring Locations and Geologic Map

Surficial slide debris was encountered within the descending slope northern portion of the site, below the wastewater treatment plant clarifier tank, in borings BH-10, BH-12 and BH-13 from the surface to approximately 5.0 feet to 7.0 feet bgs, were explored, may be as much as 8.0 feet to 9.0 feet thick. This material was a fine to coarse-grained silty sand and clayey sand, loose, moist to wet, and various shades of yellow and brown.

Geologic mapping of the surface and subsurface exploration of the distressed slope in question, below the wastewater treatment plant clarifier in question, determined that the primary mode of failure is a surficial slide of approximately 4 feet to 8 feet of previously placed undocumented artificial fill and the colluvial soil within the subject slope. The surficial stability of the upper 4 feet of the previously placed undocumented artificial fill and colluvium in the existing subject slope was also evaluated under saturated conditions as was determined to be unstable.

The area of the surficial slide, indicated on Figure No. 2, *Approximate Boring Locations Map*, should be cleared of all vegetation and debris in areas to be repaired, The approximate location of a 1.5:1 (h:v) temporary stabilization fill slope and keyway are indicated on the Figure No. 3, *Approximate Locations of Temporary Remedial Grading Map*. The actual design of the 1.5:1 (h:v) temporary stabilization fill slope should be accomplished by a California licensed Civil Engineer and should also be reviewed by the geotechnical consultant.

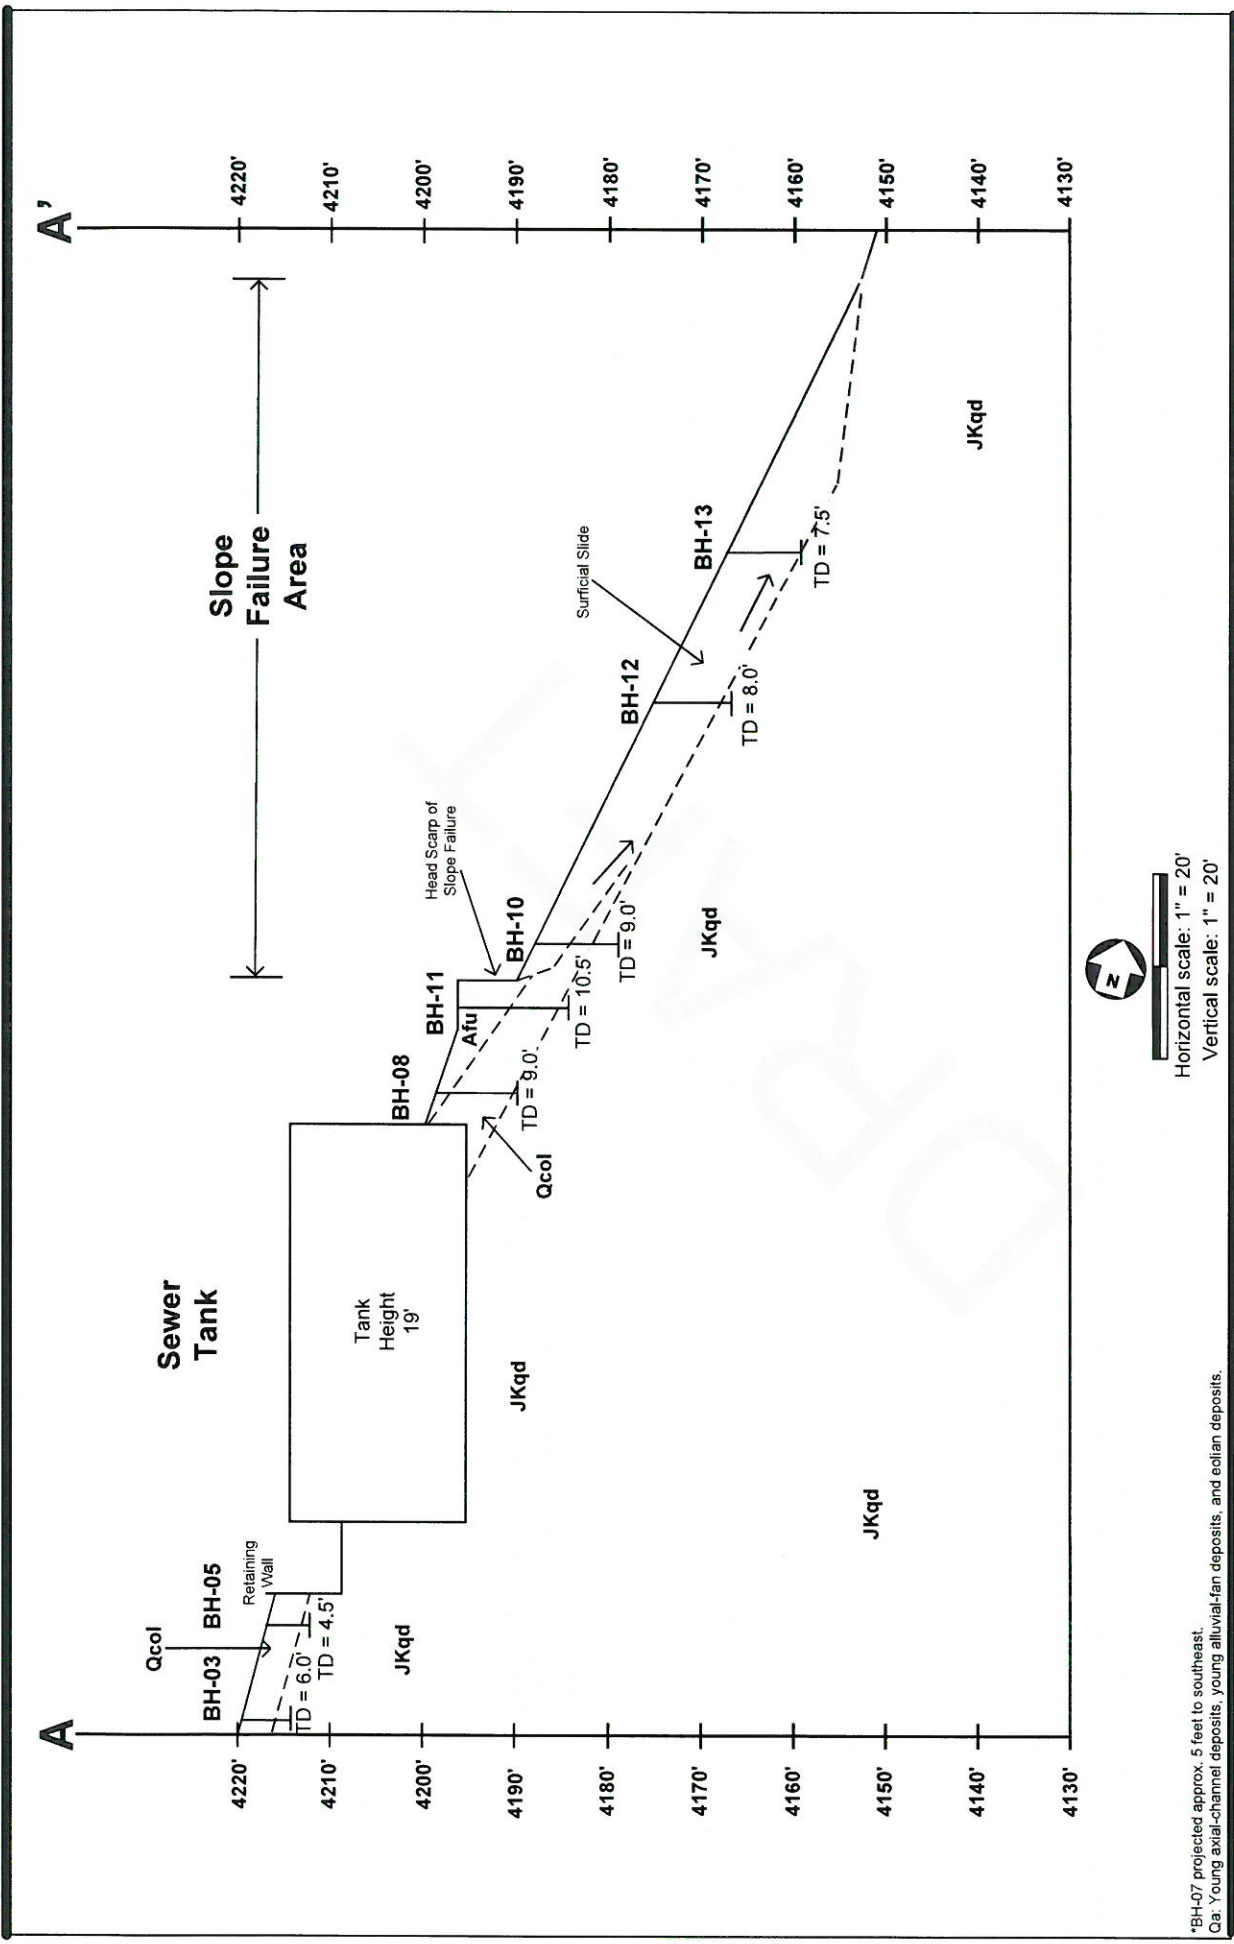
GEOLOGIC CROSS SECTION A-A'

A detailed description of the earth materials encountered during our field exploration is presented in Appendix A, *Field Exploration*. Figure Nos. 4a through 4c, *Geologic Cross Sections A-A' through C-C'*, is provided to illustrate current surface and subsurface conditions by using data from the exploratory borings drilled on May 24 to 31, 2024.

The anticipated gross stability of temporarily stabilizing the surficial slide within the existing slope, below the wastewater treatment plant clarifier, by replacing the upper portion of it with a compacted stabilization fill slope, at a gradient 1.5:1 horizontal to vertical (h:v) or fatter, under static conditions was evaluated using the Slide 8.0 software (RocScience, 2018). Pseudostatic analyses using a seismic coefficient of 0.15 were performed in order to evaluate the stability of the slopes during a large earthquake. The distressed slope in question was evaluated only for dry static and pseudo static conditions. This slope area was selected as a worst-case condition due to their heights, slope ratio and materials encountered. The purpose of the analyses was to evaluate the anticipated factors of safety against failure of the proposed stabilization fill slope under a variety of conditions. The proposed temporary stabilization fill slope was determined to be grossly stable. The slope location and cross section is presented in Figures No. 2 and 4a through 4c.

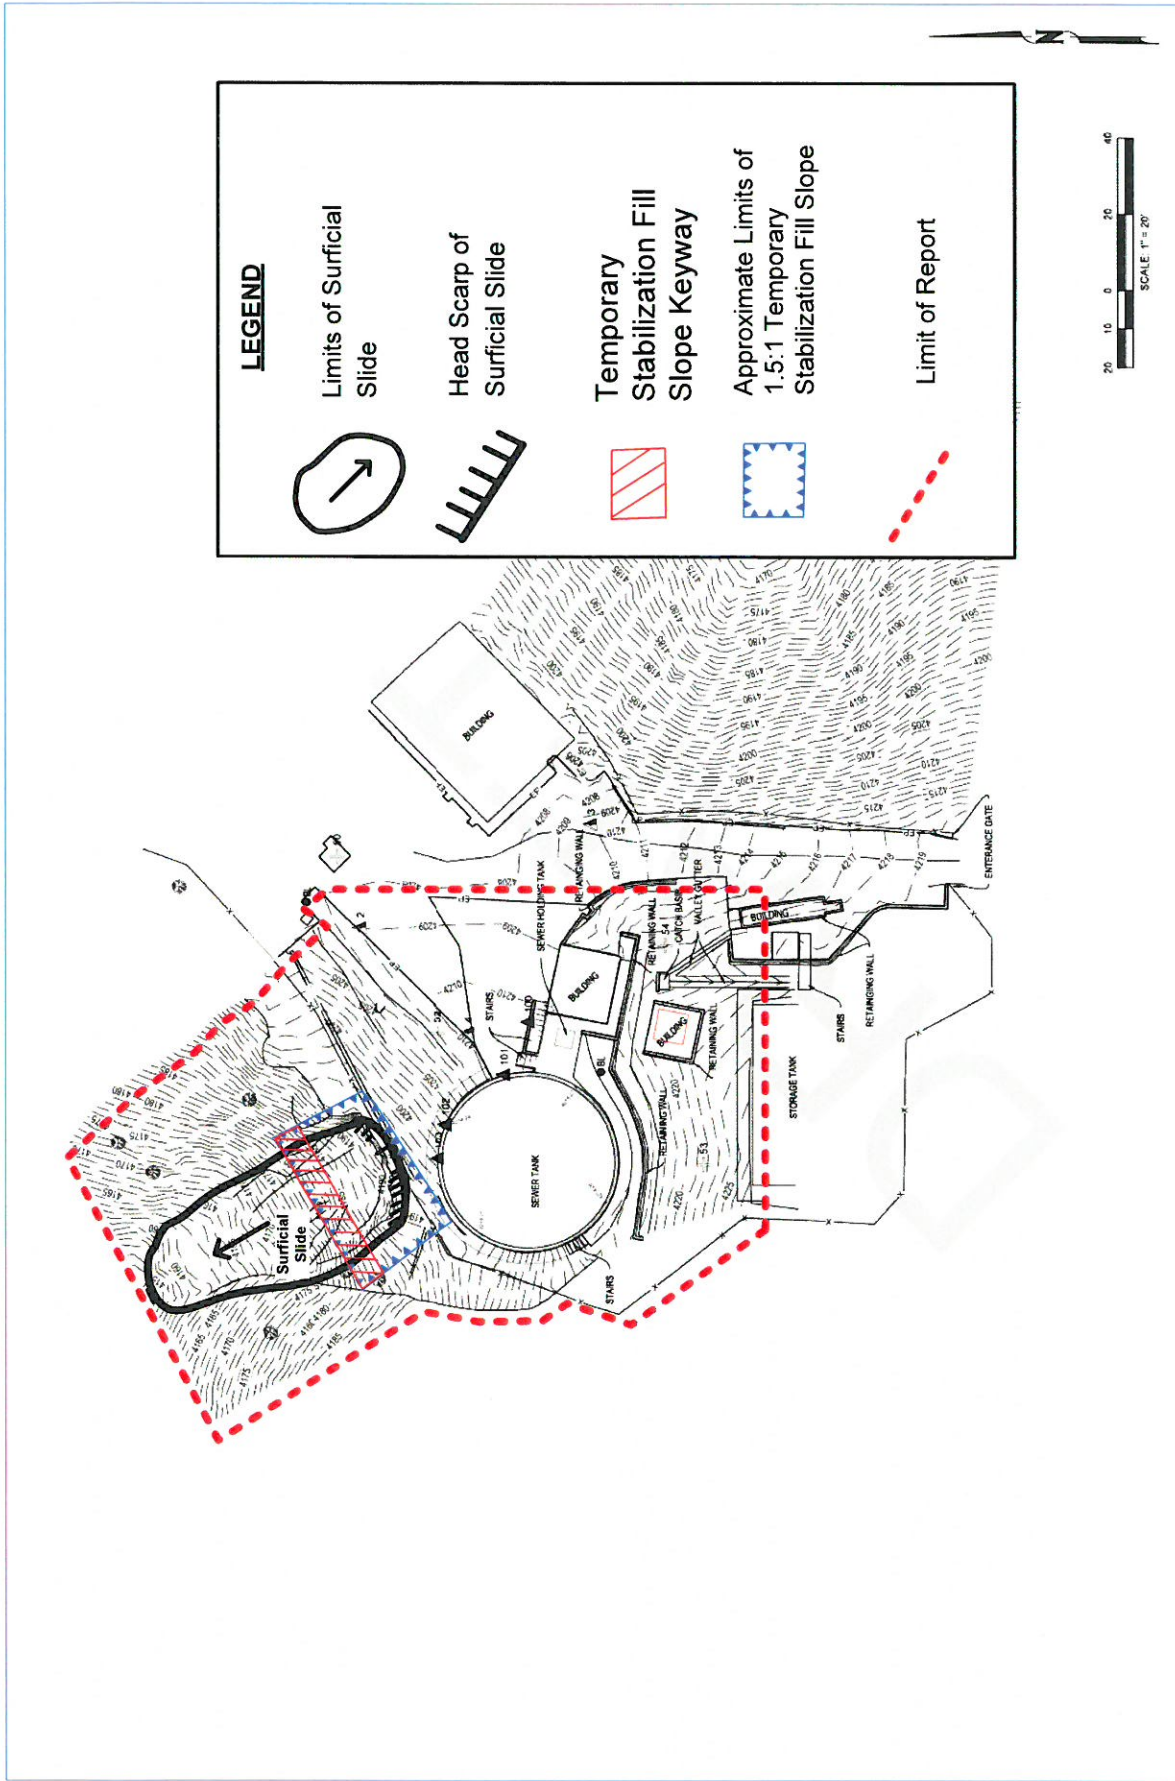
Approximate Locations of Temporary Remedial Grading Map

Therefore, we believe the primary cause of slope failure to be saturation of the previously placed undocumented artificial fill and the upper colluvial soils from repeated rain events over the years following construction as well as by surficial discharge of water from the above the distressed area. **Therefore, it is important that the water be controlled and directed away from the slope face, especially in the area of surficial slope failure.**

Due to the sloping conditions below the wastewater treatment plant clarifier tank a temporary stabilization fill slope should be placed in order to create a level working area for installation of the temporary shoring piles, prior to construction of the ultimate 2:1 (h:v) stabilization fill slope. This can be an option to provide temporary stability if construction timing due to rain/snow seasons if needed. The temporary fill slope can be constructed at a 1.5 (h:v) with a keyway establish at the toe of the slope at an approximately elevation from 4,175 to 4,180. The keyway should be approximately 7 feet to 8 feet deep and extend to a width of at least 10 feet horizontally into competent undisturbed bedrock. The back cut for the stabilization fill slope should be no steeper than a 1:1 (h:v) above the keyway.

Slope subdrain should be placed on in the back cut of the recommended stabilization slope and the temporary fill slope. following overexcavation of unsuitable soil materials to competent bedrock. The subdrains should be placed on bedrock against the back cut and consist of a 4-inch perforated schedule 40 PVC pipe, or equivalent, encased in at least 6 cubic feet per linear foot of 1/2-inch to 3/4-inch crushed gravel, wrapped in filter fabric (Mirafi 140 or equivalent). The first subdrain level should be placed at the base of the temporary stabilization fill slope, just above the keyway. Other subdrains should be spaced at least every 15 vertical feet. The subdrains should have outlets consisting of 4-
