SUBJECT: Engineering Report from Webb Associates for the Hillside Stabilization at Seeley Creek WWTP

GEOTECHNICAL SLOPE DISTRESS INVESTIGATION REPORT

SEELEY CREEK WASTEWATER TREATMENT PLANT CLARIFIER AREA City of Crestline, San Bernardino County, California

CONVERSE PROJECT No. 24-81-141-01

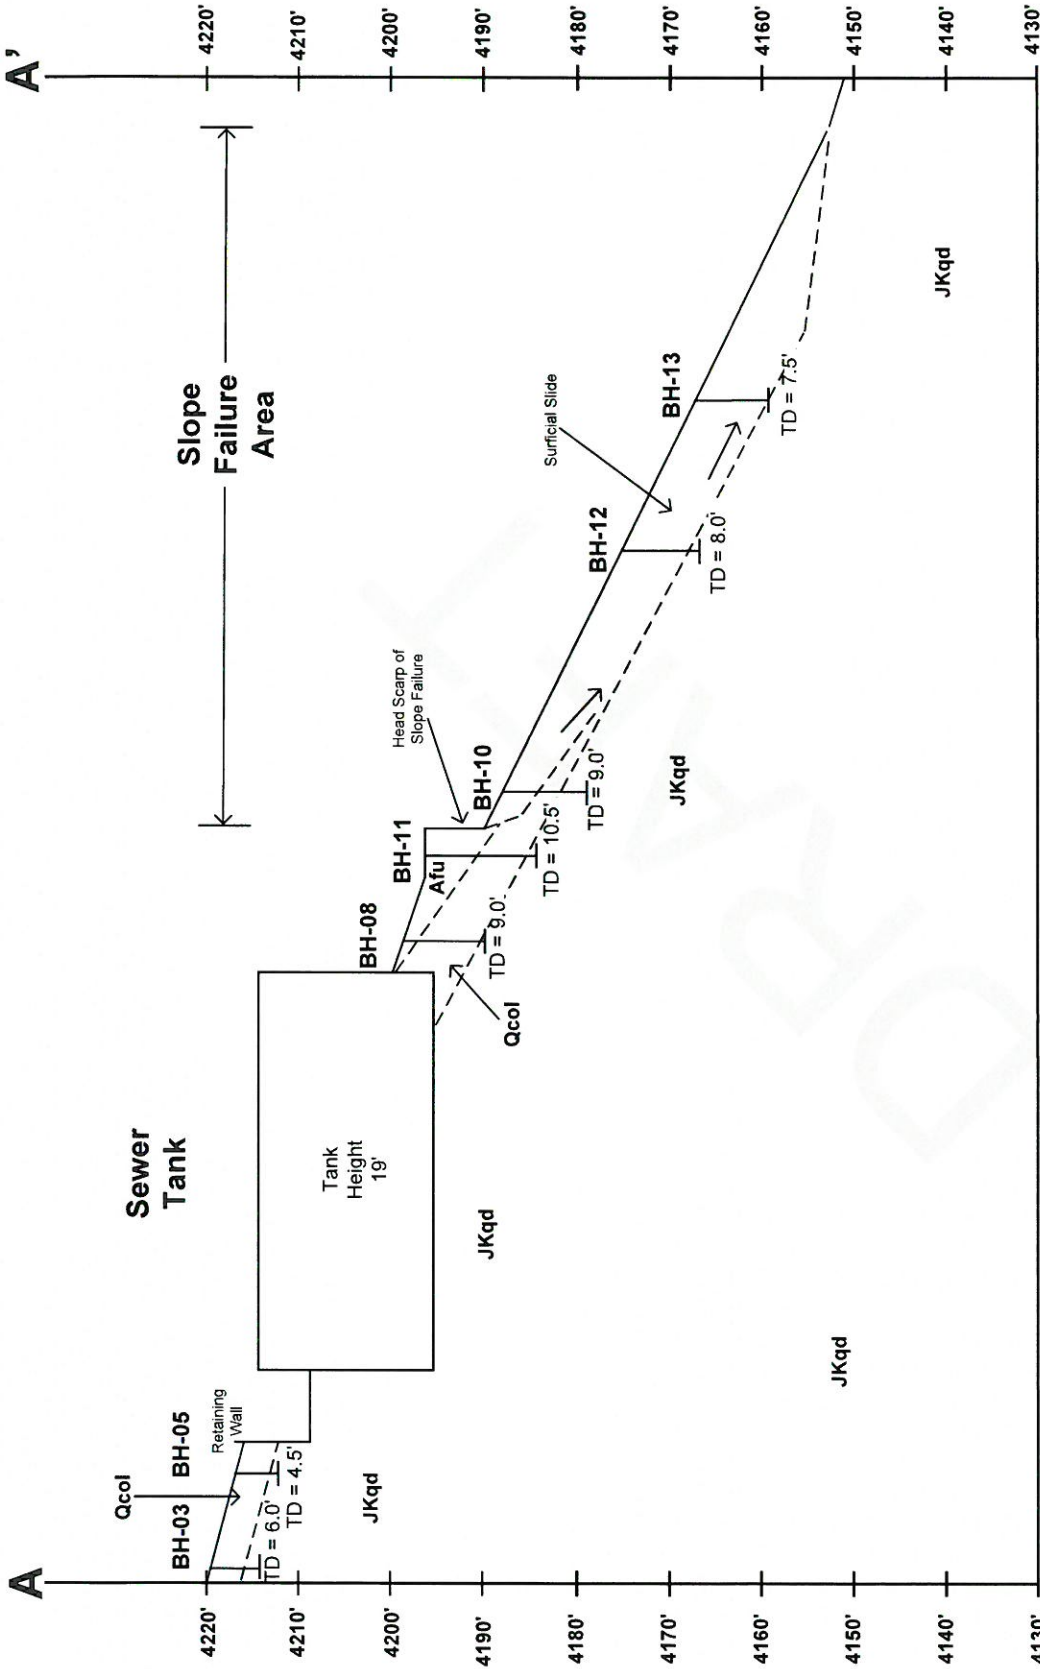
GEOLOGIC CROSS SECTION A-A'

Geologic mapping of the surface and subsurface exploration of the distressed slope in question, below the wastewater treatment plant clarifier in question, determined that the primary mode of failure is a surficial slide of approximately 4 feet to 8 feet of previously placed undocumented artificial fill and the colluvial soil within the subject slope. The surficial stability of the upper 4 feet of the previously placed undocumented artificial fill and colluvium in the existing subject slope was also evaluated under saturated conditions as was determined to be unstable.

Therefore, we believe the primary cause of slope failure to be saturation of the previously placed undocumented artificial fill and the upper colluvial soils from repeated rain events over the years following construction as well as by surficial discharge of water from the above the distressed area. **Therefore, it is important that the water be controlled and directed away from the slope face, especially in the area of surficial slope failure.**

The area of the surficial slide, indicated on Figure No. 2, *Approximate Boring Locations Map*. The approximately 3 feet to 13 feet of artificial fill, colluvium and slide debris soil should be overexcavated into competent undisturbed bedrock and replaced as a compacted stabilization fill slope. At the base of the surficial slumps a keyway should be excavated. The keyway should be approximately 4 feet to 5 feet deep and extend to a width of at least 15 feet into competent undisturbed bedrock. The back cut for the stabilization fill slope should be no steeper than a 2:1 (h:v). The approximate location of a 2:1 (h:v) stabilization fill slope and keyway are indicated on Figure No. 3, *Approximate Locations of Temporary Remedial Grading and Temporary Piles Map*. The actual design of the 2:1 (h:v) stabilization fill slope should be accomplished by a California licensed Civil Engineer and should also be reviewed by the geotechnical consultant.
