SUBJECT: Engineering Report from Webb Associates for the Hillside Stabilization at Seeley Creek WWTP

GEOTECHNICAL SLOPE DISTRESS INVESTIGATION REPORT

SEELEY CREEK WASTEWATER TREATMENT PLANT CLARIFIER AREA City of Crestline, San Bernardino County, California

CONVERSE PROJECT No. 24-81-141-01

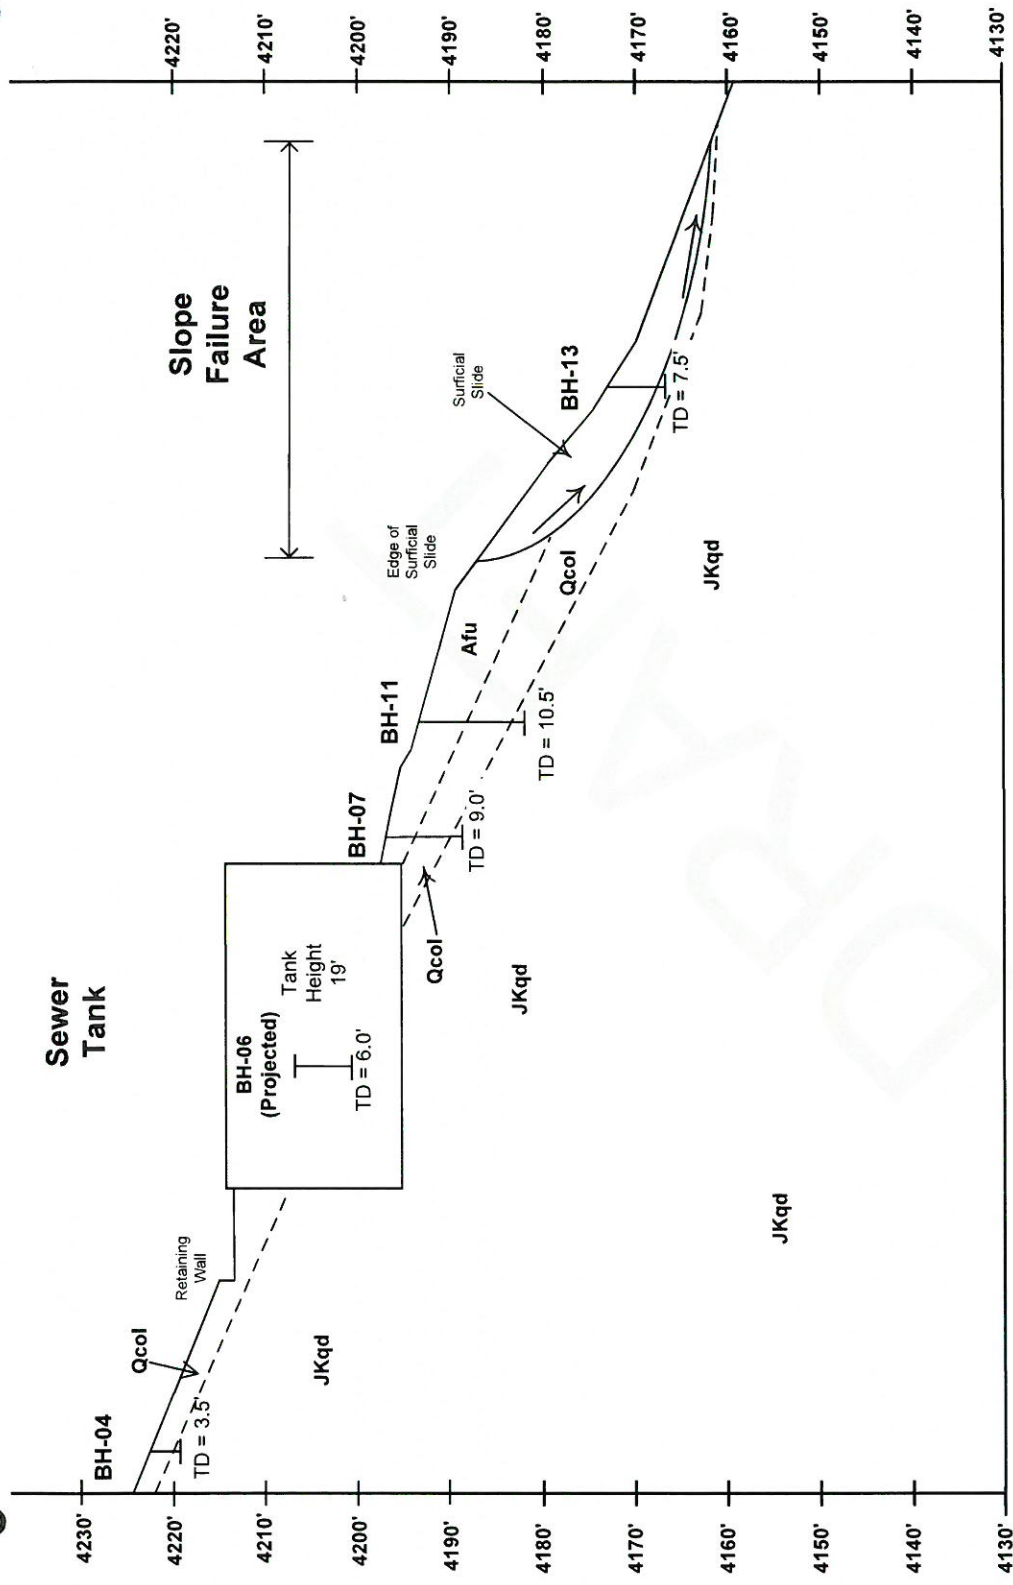
*BH-06 projected from approx. 18 feet to southwest.
*BH-10 projected from approx. 24 feet to the southwest.
*SM-Qa: Young axial-channel deposits, young alluvial-fan deposits, and eolian deposits.
